Central Rivers Train Maintenance Depot.

SignaGrip

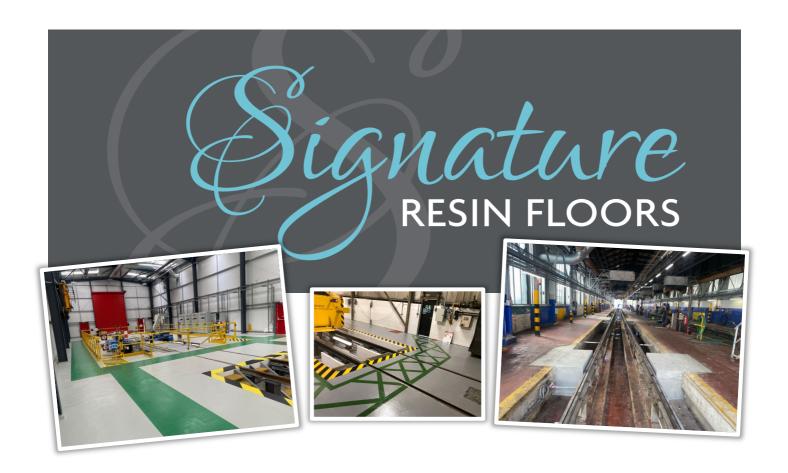
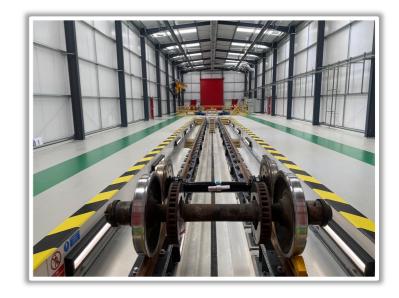
This railway underwent a significant transformation. The original coating system was failing due to contamination from oil within the substrate, leading to widespread delamination. Our team removed the defective coating, thoroughly prepared the substrate & walls and applied an oil-tolerant primer to ensure proper adhesion.

To rebuild the surface, we applied a scratch coat followed by two layers of high-build epoxy. Natural quartz was incorporated to enhance slip resistance, and the project was completed with clearly defined safety demarcations for improved visibility and safety.
